## **Pre-Excavation Grouting through water bearing zone under high pressure under extreme flow conditions**

### **1.0 ABSTRACT**

The Yung-Chung-Tunnel in Taiwan, constructed for the Taiwan-East Railway Bureau, collapsed during construction when a water bearing, fractured marble zone was intersected. The inflow was approximately 4,000 liters/second. In spite of 30 relief holes the total inflow into the tunnel remained constant.

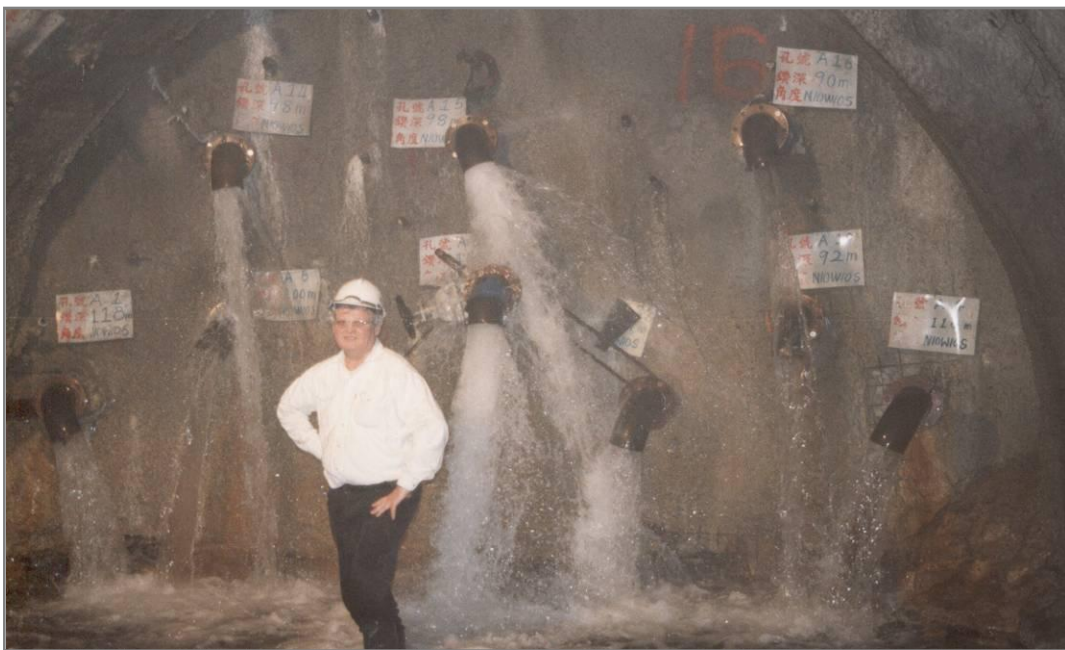
An additional drainage tunnel (Figure 1) was excavated, from where 36 pressure relief holes, 20cm in diameter were drilled, intersecting the flow path well above the main tunnel. These drainage holes also produced approximately 3-4m<sup>3</sup> of water/second, but failed to significantly reduce hydrostatic pressure and flow through this water bearing formation (with reference to Figure 2). For this reason, this tunnel inflow was considered the “highest tunnel inflow in the world at the time”.

Figure 1: View of Drainage Tunnel with 36 pressure relief pipes

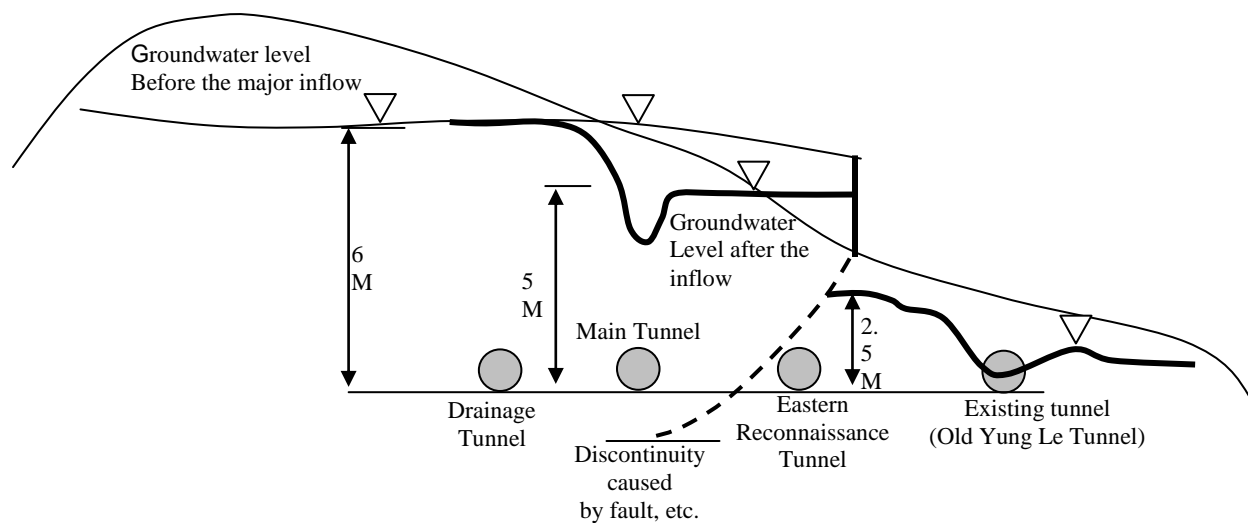
The geology in and near the tunnel inflow area consists of amphibolite, green shist (including altered chert and “marble I”), marble (“marble II”), green shist and quartz mica shist (including altered chert). These layers dip upwards toward both the north and the south and their strike is from north-west to south-east. Marble II, the main conductor of the water, seemed to taper off near the point where it intersected with the east planned tunnel alignment. Except for this point, this Marble II layer has good continuity, extending at least 1.2km to the west and 0.5km to the east.

Figure 2: Conceptual view of the water bearing mechanism of the New Yung Chung Tunnel

The maximum thickness of the water bearing formation is 70m. Two major joints, which cross at right angles with each other are developed in the marble layers. One is running parallel with the shist and has been noticed in several outcrops, some near a cliff where it caused secondary breakage and at some spots forming porous coarse breccia. Along the already weakened line of joints and shistosity are ant-nest like, small leaching channels which are often filled with fine gouge or fine gravel. A lot of this infill material washed into the tunnel.

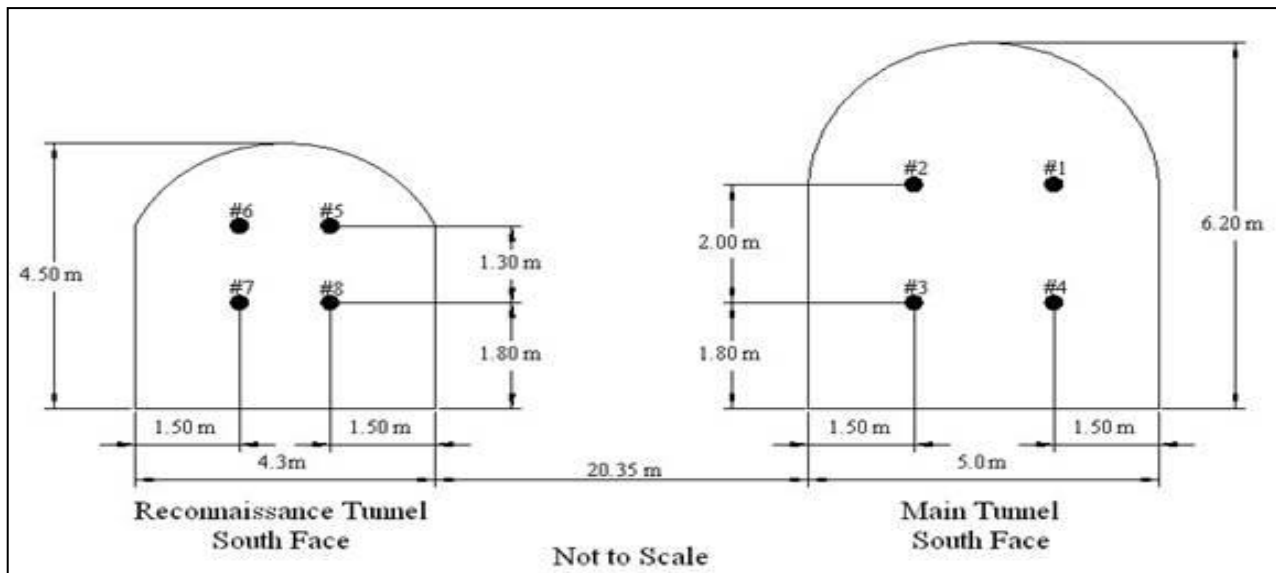
Figure 4

- Drill 8 cased holes (the primary grout holes) for the installation of the steel sleeve pipes: 4 per tunnel (refer to Figure 4)
- Perform the drilling and grouting activities from the south side, where a lot of space was available to accommodate this work
- Start the holes by installing heavy duty steel standpipes, grouted in place and tested to a pressure of 15 Mpa; attach a blow-out-preventor on each stand pipe, prior to drilling into the marble zone

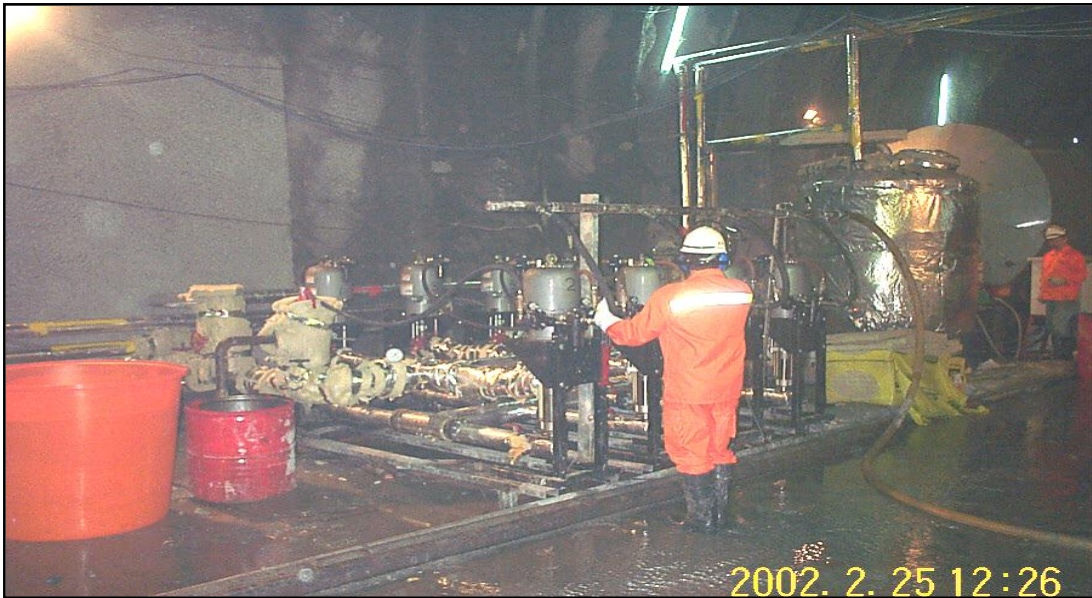
- Design and install a hot bitumen grout plant in the tunnel, within 50m of the tunnel face, inclusive of a 40,000 liter heated and insulated holding tank for the hot bitumen. The grout plant had to be capable to inject 20m<sup>3</sup> of hot bitumen per hour at pressures in the order of 7 - 12 Mpa. It involved 8 grout pumps acting in parallel, set up side by side (Figure 5).

Figure 5: Grout plant in foreground, insulated bitumen holding tank in background

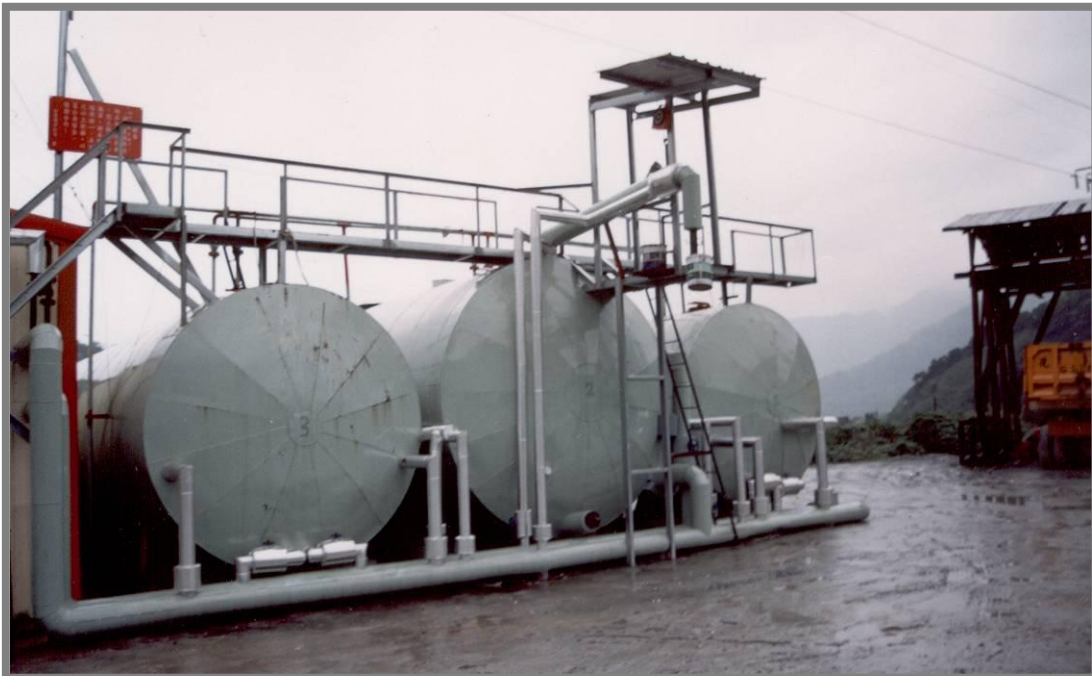
- The on-site bitumen receiving system near the portal of the tunnel including off loading facility, temperature re-boosting system and large (300m<sup>3</sup>) holding tanks (Figure 6)

Figure 6: Off Loading Facility and insulated Bitumen holding tanks outside tunnel

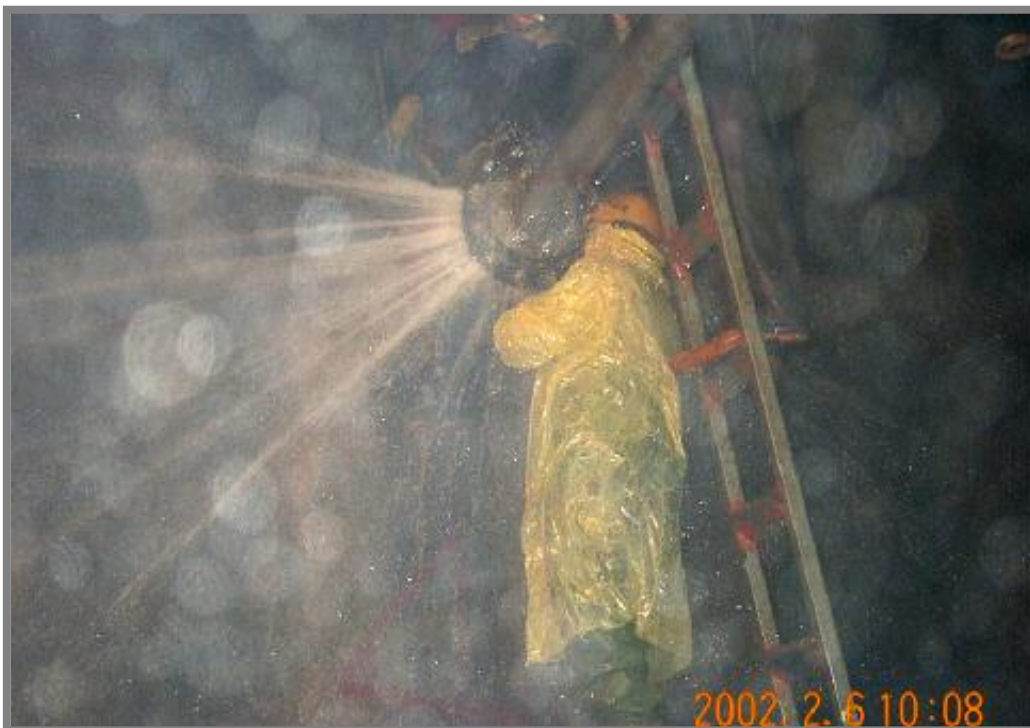
Figure 7:

The drilling of the cased holes for the installation of the in-hole grout delivery system –including the sleeve pipe – was not an easy undertaking (Figure 7). In each hole, as soon as the marble zone was intersected, “all hell broke loose” and water inflows of more than a hundred liters/second under pressure of 5 Mpa gushed into the hole. Based on the outflow, the average permeability of the water bearing marble formation was approximately 120-150 Lugeon (0.0013 – 0.0016 cm/s). All 8 primary holes were extended -albeit with great difficulty – to the far end of the marble zone. The in-hole grout delivery system consisted of 3 concentric heavy duty steel pipes (to facilitate pre-heating of the in-hole grout delivery system) ending into a sleeve pipe, located in the marble zone. Barrier bags were inflated with cement based grout around the in-hole grout delivery pipe and any residual seepage around these pipes was sealed using water reactive, hydrophobic polyurethane grout.

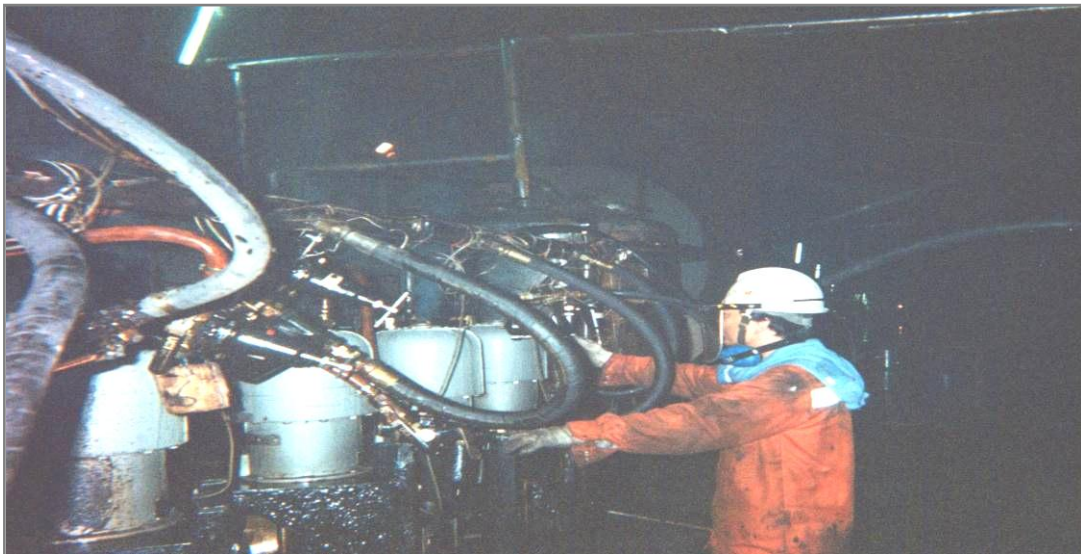
Figure 8

During the grouting of the first hole, it was quickly discovered that the 8 single action piston pumps operating at high pressures (10 Mpa) were not capable of operating more than 1 hour without the need to be repaired (Figure 8). The mechanics could not keep up with replacing the seals. It was also discovered that the temperature of the bitumen in the holding tanks outside the tunnel needed to be increased to 220 degrees Celsius to be able to conduct a permeation grouting program in this type of a formation. Eventually we ran out of spare parts for the grout pumps, before phase I could be completed. During phase I, only 6 of the 8 primary holes were grouted. The injected volumes in each of the holes fell short of the target volumes, necessary to create overlapping grout cylinders. The volumes injected varied between 17 and 68 cubic meters of bitumen per hole. All 6 holes came to refusal because of technical or logistical problems. The team needed to regroup at the end of phase I...

An additional 6 holes were drilled for the grouting of the second phase and the sleeve pipes installed. New, inexpensive pump seals were manufactured in Taiwan. A number of key-positions in the bitumen grouting operation were taken over by the local people.

Phase II was very successful. The pump seals were standing up better under the high pump pressures (90 -120 minutes in lieu of 60 minutes for the North America seals). The temperature of the bitumen was adequate (200-220°C). The mechanics managed to keep 5 out of 8 grout pumps operational at all times. Injection rates of 10-14 cubic meters per hour were maintained.

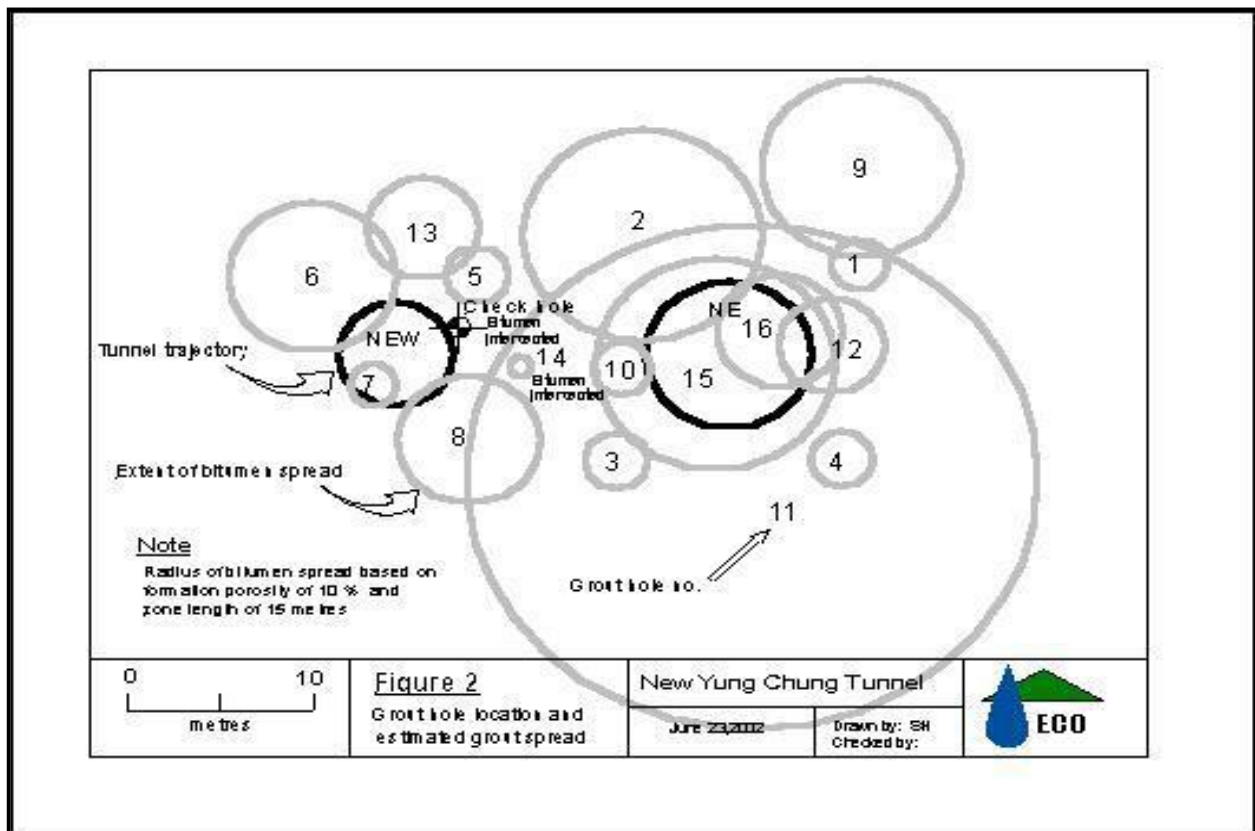
At the end of the second phase, all the grouting information was assessed and 2 target areas were identified in which more grout needed to be placed (Figure 9). The average permeability of the formation (based on the water outflow) had been reduced to less than 5 Lugeon near the end of Phase II.

Figure 9: Grout hole lay-out for the 3 grouting phases and theoretical grout spread.

For phase III only two holes were drilled. The grouting was conducted flawlessly. Each hole required approximately 50 hours of continuous grouting. The bitumen placed during the second, but especially during the third phase filled up shrinkage gaps caused by the thermal shrinkage of the bitumen. During the 3 grouting phases, a total of 3,084,000 liters of hot bitumen were successfully injected. No bitumen washed out, in spite of the fact that water was still gushing

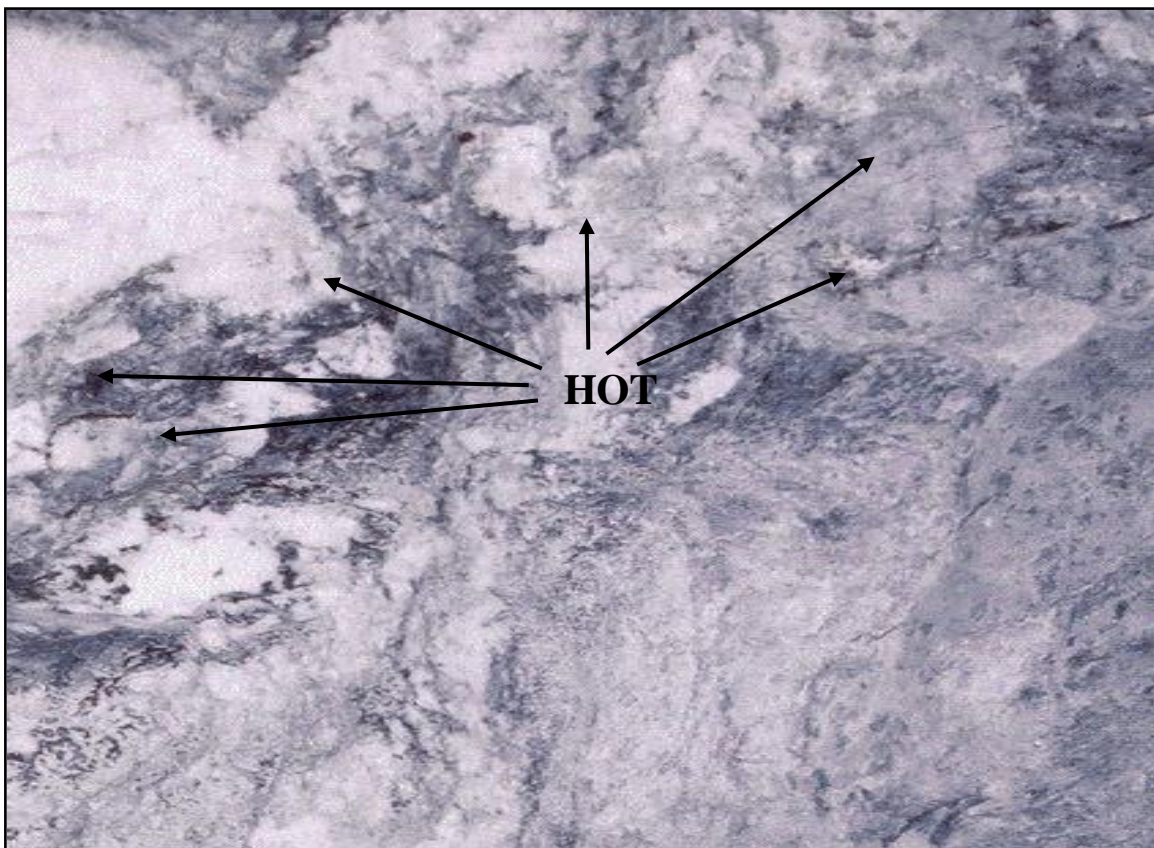
A formidable and challenging grouting project made it possible to excavate – problem free – the reconnaissance tunnel and the main Yung Chung railway tunnel. Hot bitumen was observed to have filled even the smallest hairline fissures in the marble formation (Figures 10, 11 & 12). The residual inflow into the tunnel when crossing through the water bearing zone was in the order of a few liter per minute. The grout pipes acted very effectively as forespiling and prevented excessive squeezing of the green shist. Hydro-fracture planes filled with bitumen were observed criss-crossing the green shist. One of the most difficult bitumen grouting projects in history had been completed successfully. Hot bitumen grouting proved - once again - to be a formidable tool in the hands of experienced grouting practitioners.

Figure 10: View of tunnel face through Marble II formation.

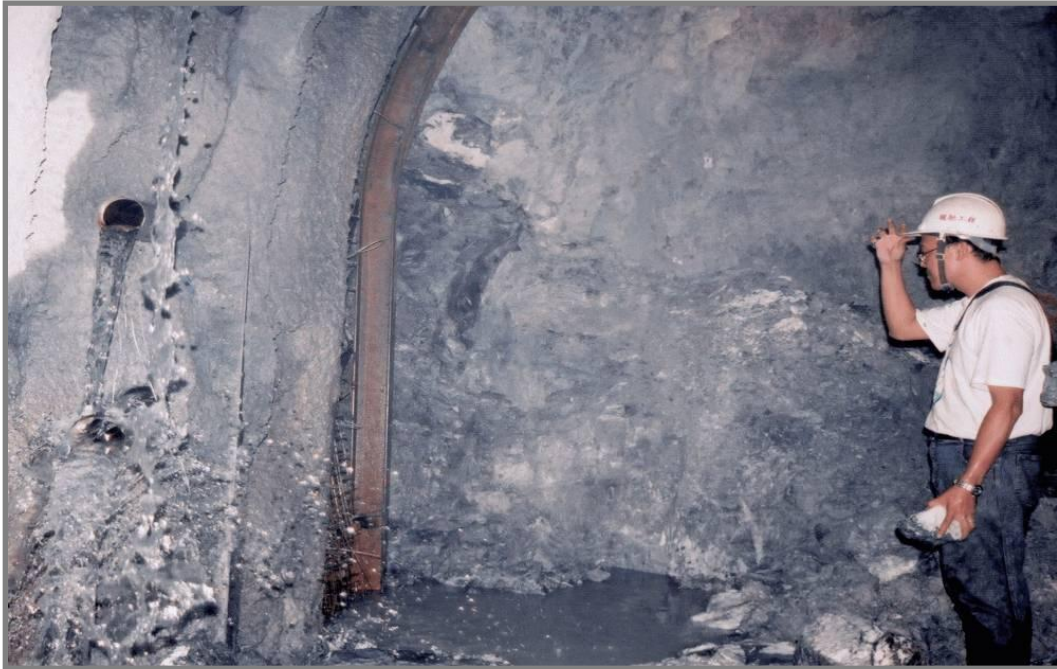
Figure 11: Tunnel face entering the water-bearing grouted zone

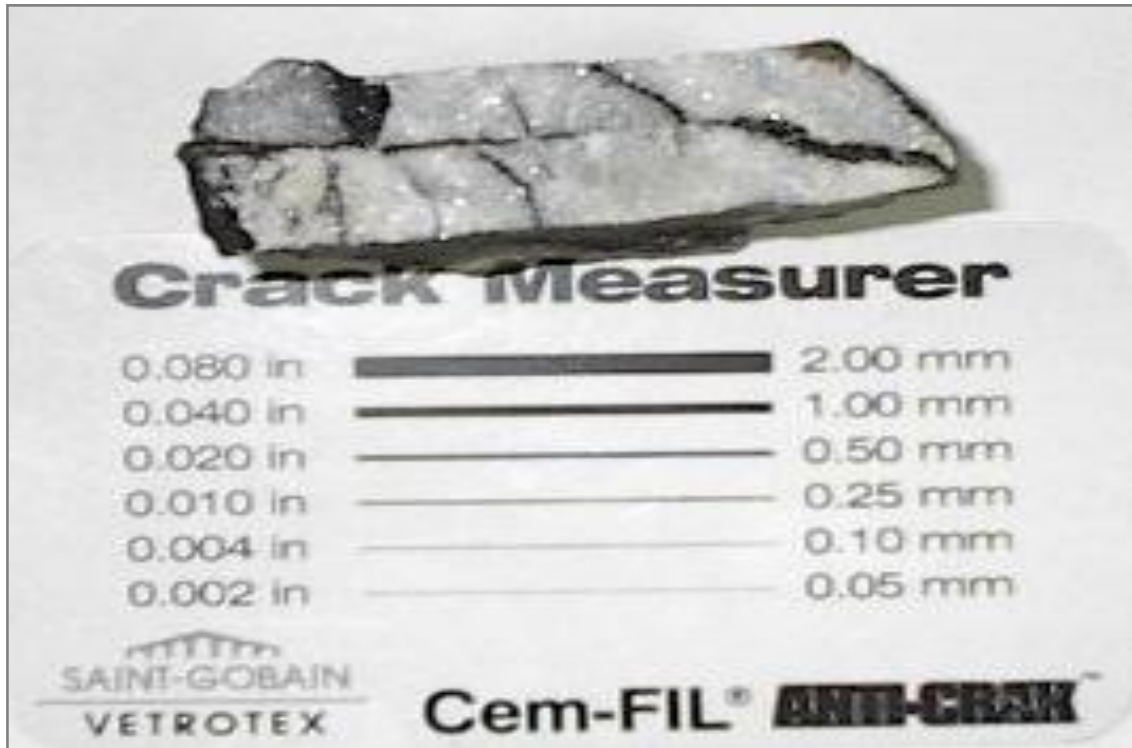
Figure 12: Sample of marble impregnated with Hot Bitumen
