Rehabilitation of the 80-Year-Old North Outfall Sewer (NOS) Tunnel

ABSTRACT: In 1990, a residential area above the North Outfall Sewer (NOS) tunnel constructed in 1924, experienced subsidence. After sewage was diverted into the North Outfall Replacement Sewer (NORS), soil probing from within the tunnel was conducted, soil-improvement options were developed, and a preferred grouting scheme was analyzed by numerical modeling to evaluate the stability of the 80-year+ old tunnel liner under grouting-induced loading conditions. This paper discusses the initial field investigation and the development and analysis of a grouting scheme originally intended to be implemented before relining of the tunnel. The scheme was later modified, and the new liner was installed before the final probing and grouting work was done.

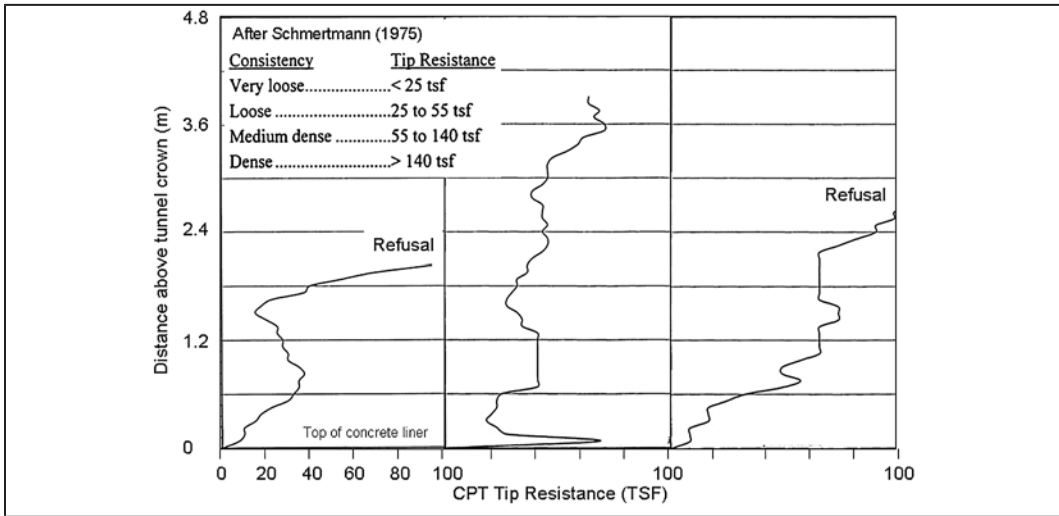
Figure 9. Typical CPT tip-resistance profiles

Typical profiles of CPT tip resistance are shown in Figure 9, indicating the presence of very loose soil zones within approximately 1 to 3 m above the tunnel crown. These zones likely originated from initial voids created around the tunnel liner during the original construction by way of poorly backfilled annular space and/or cave-ins during mining, as well as rotting of the timber cribbing and temporary supports left in place. Such voids then slowly migrated upwards, eventually causing surface subsidence. This process can take decades in fine to medium-grained sands, which temporarily lose their capillary-tension based (apparent) cohesion when seasonal rainwater seeps into the ground. During such episodes, the leading edge (roof) of the upward-migrating void (chimney) gradually unravels filling the tail end of the chimneys with loose debris.

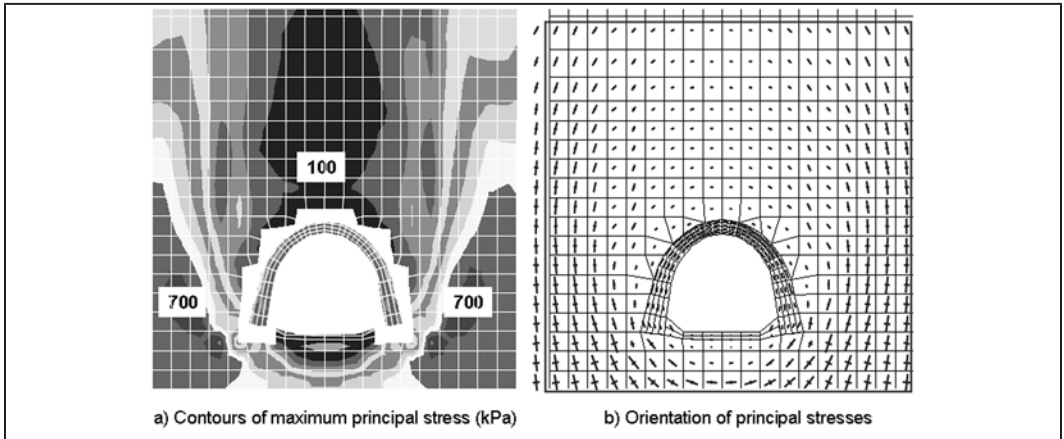
Figure 13. Soil arching after crown is allowed to sag 8 cm (Analysis Step 2)

Existing subsurface information clearly indicated the presence of voids or loose soils above the tunnel crown. Thus, the tunnel crown was allowed to sag approximately 8 cm by way of temporarily relaxing the stiffness of the tunnel liner. The resulting transfer of overburden load to the soil around the tunnel (arching) caused a significant reduction of compressive stress in the tunnel liner from 2000 kPa to 200 kPa. Figure 13 shows contours and orientation of principal stresses due to soil arching.

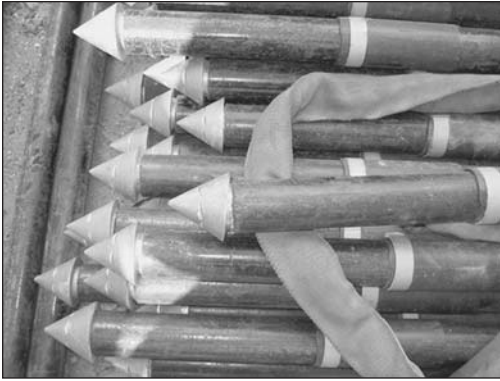
Figure 19. Sleeved grouting pipes with sacrificial cone

The rest of the original program was left largely unchanged with the primary emphasis on soil probing. This was done by reading the backpressure of the jacks that installed the sleeve port grout pipes shown in Figure 19, which had sacrificial cone tips slightly larger in diameter than the standard ASTM D5778 CPT. At the outset of the program, tip-resistance data from these modified cones were correlated in side-by-side testing with standard CPT equipment.
