North American Tunnelling Conference
San Francisco, June 7-11, 2008

**Pre-conditioning/Pre-excavation Grouting of the Soils Prior to Tunnelling Below Highways
& Railways:
Case Histories from the Past Decade**

Alex Naudts¹ and Ward Naudts²

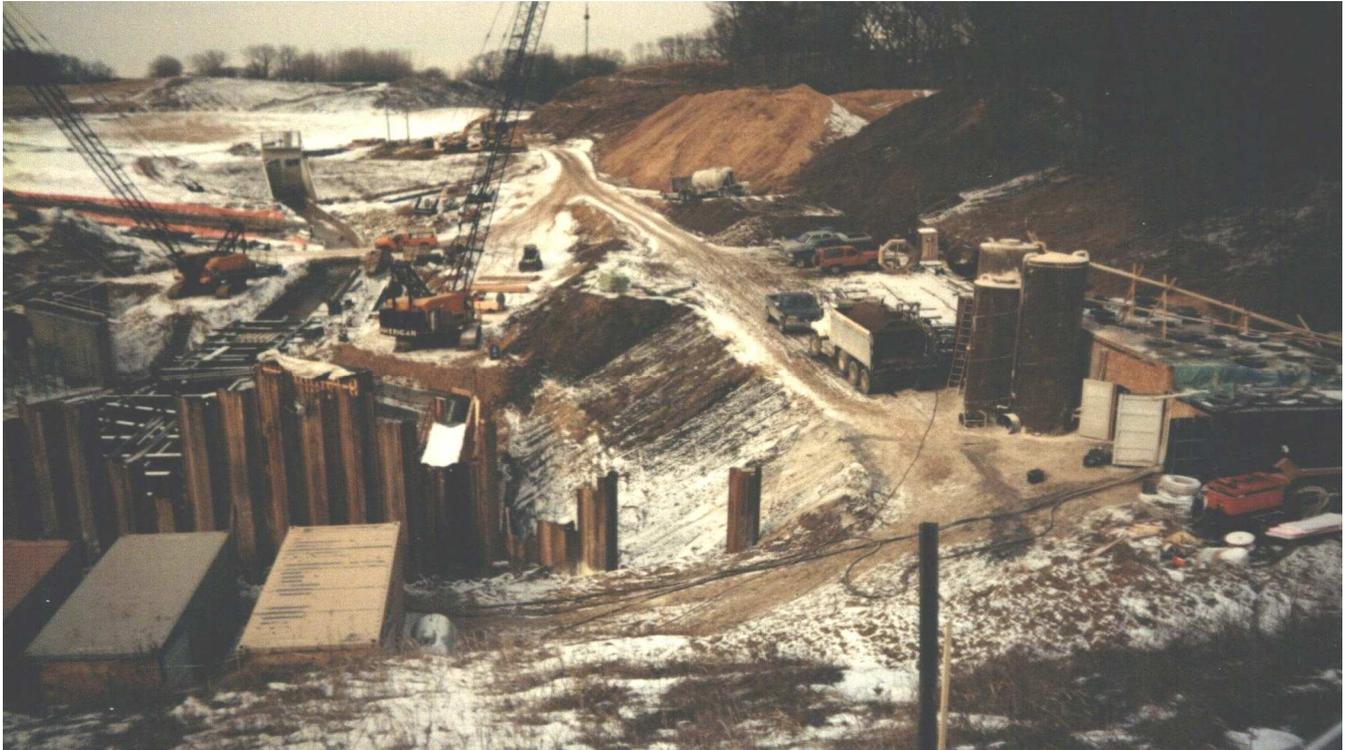
Photograph 3: General view of the batch plant and grouting lay-down area

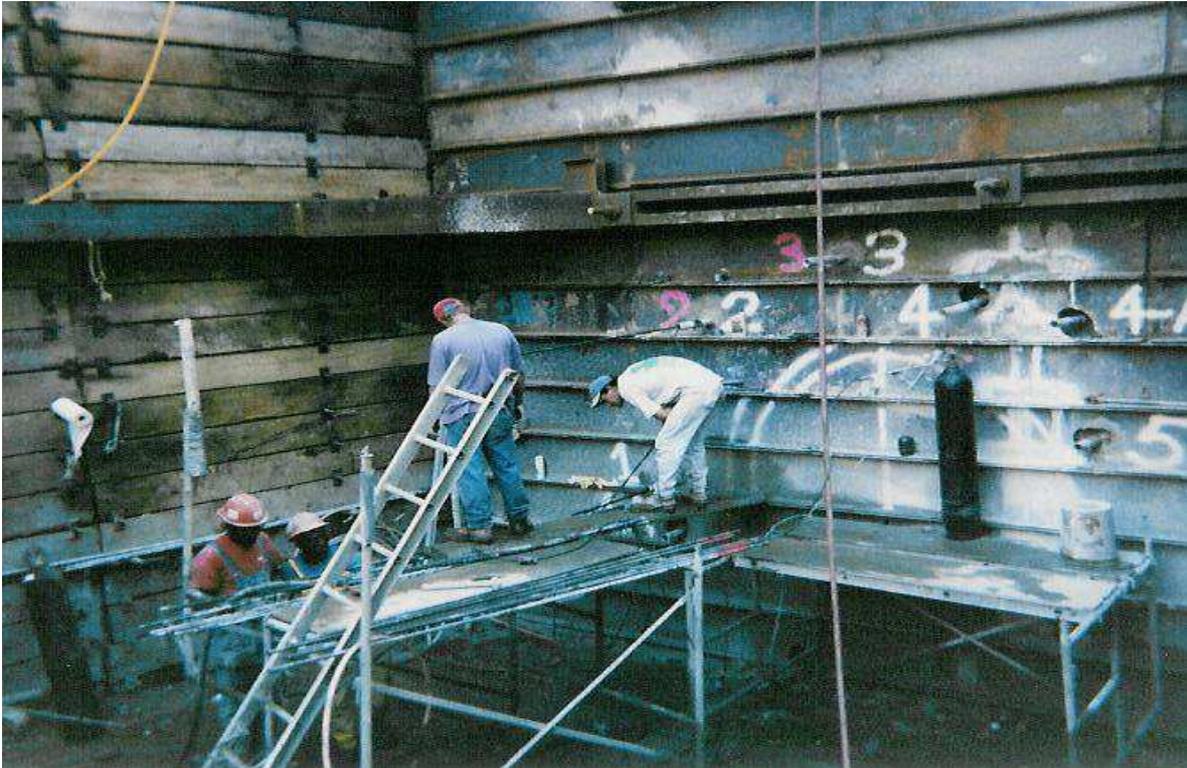
The grouting program. An extensive grouted soil-conglomerate arch was created above the tunnel trajectory to prevent settlement of the CP Rail tracks during the excavation of the sewer tunnel through the underlying embankment. Photograph 4 depicts the grouting crew during the injection of sodium silicate grout via one of the sleeve pipes. The grouting program included the following:

Photograph 4: Grouting crew performing injection of sodium silicate based grout via the sleeve pipes

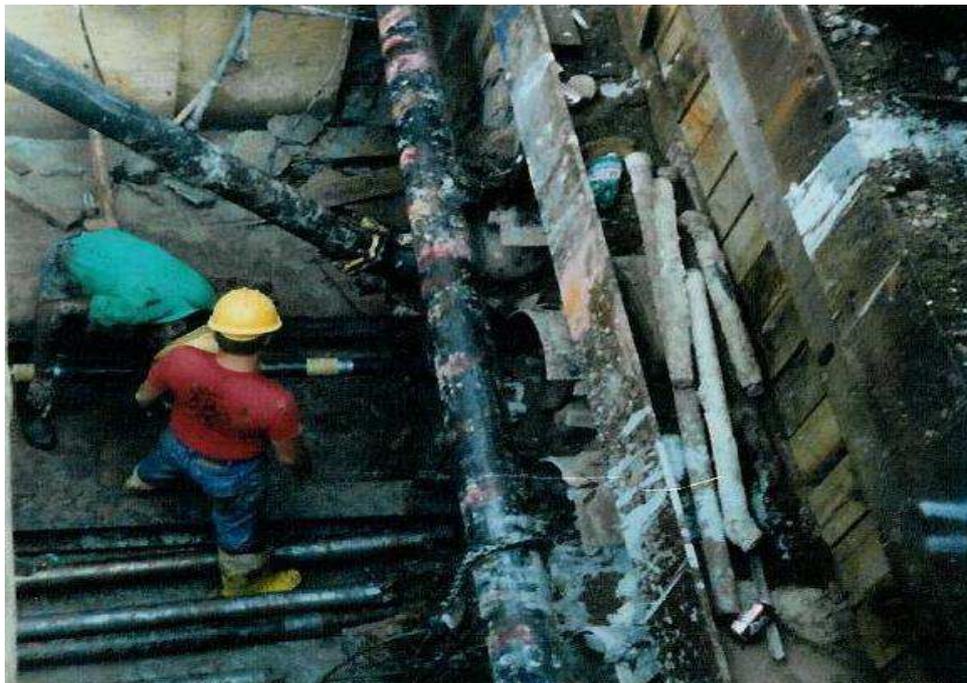
Photograph 5: Grouting crew during the installation of one of the steel sleeve pipes

All sleeve pipes and several mechanical packers were built on site. A total of 25,890 gallons of regular and microfine cement based suspension grouts were injected. When the tunnelling operation resumed, no further settlement was recorded. The grout injected in the formation in conjunction with the forespiling system allowed for the safe construction of the tunnel below the railway tracks.
