Hot Bitumen Grouting – Rediscovered Heißbitumenverpressung – wiederentdeckt

Erich Schönian and Alex Naudts

Hot Bitumen Grouting – Rediscovered – Part 1

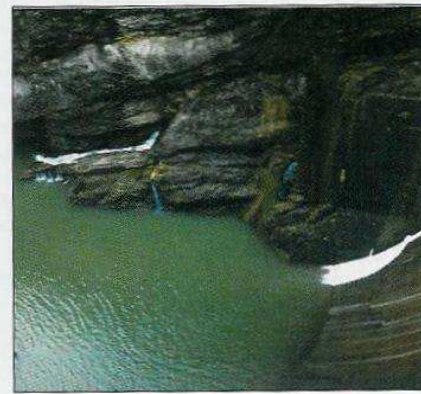
Figure 1 Lower Baker Dam - Before and After Bitumen Grouting (1982)

In 1982, the owner attempted to use water reactive polyurethane prepolymers, installed under the direction of ECO. It was injected via a "residence pipe system" which enabled to adjust the set time to within a second. After weeks of attempts, all parties came to the conclusion that the polyurethane grouts either set in the immediate vicinity of the grout pipe or that it washed out rendering it impossible to make polyurethane grouts work under the prevailing flow conditions (many fine fissure, flow-through time less than 20 seconds). Hot bitumen grouting was again successfully used to curtail the 2,200 litres per sec-

ond inflow. At the end of two weeks of grouting, the leak was reduced to 2% of its original flow. The owner could not be convinced to use bitumen in conjunction with cement based grout. The leak gradually again increased over time and has stabilized at a rate of approximately 1,000 litres per second.

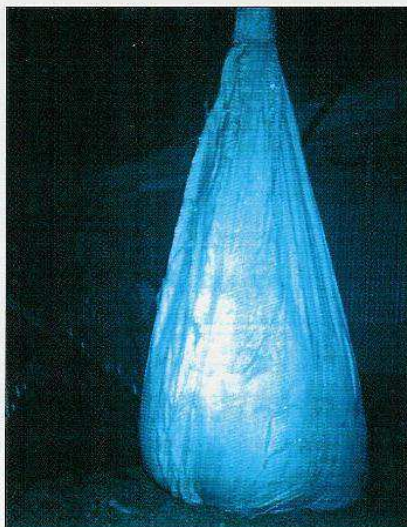
Figure 7 Geotextile bag

port (to withstand the considerable forces resulting from the hydrostatic pressure) for the future plug, a number of large geotextile barrier bags were inflated with cement based suspension grout in the tunnel (Figure 7).

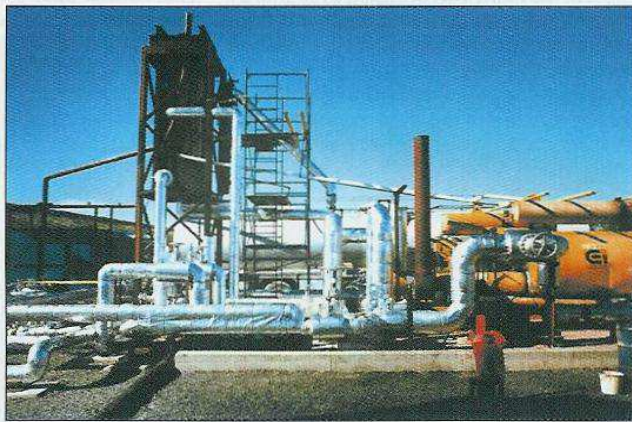
Figure 10 Custom built hot bitumen plant

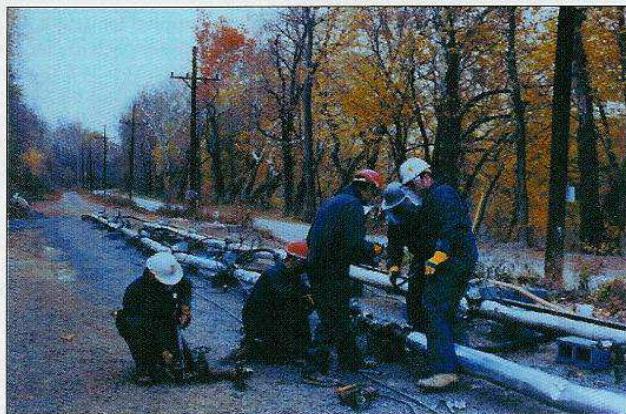
Figure 12 Insulated bitumen pipe

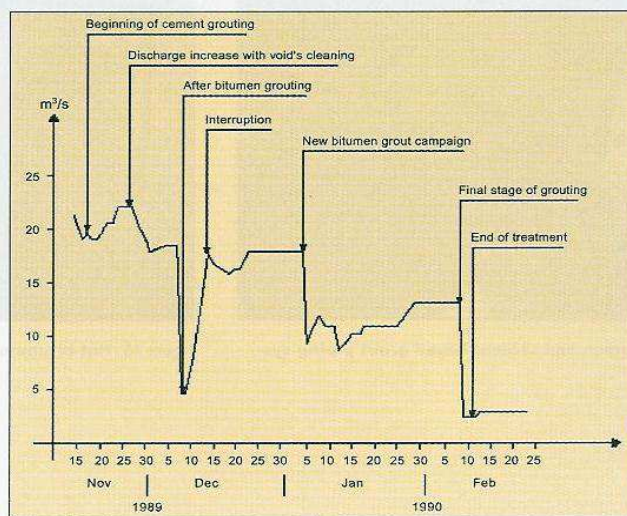
Figure 13 Flow reduction in response to bitumen grouting. Jaburu Dam (Schönian, [5])

In 1988 seepage of 20 litres/second was noted under one of the dam abutments. The seepage soon increased to 47 litres/second. An initial grouting attempt using sanded

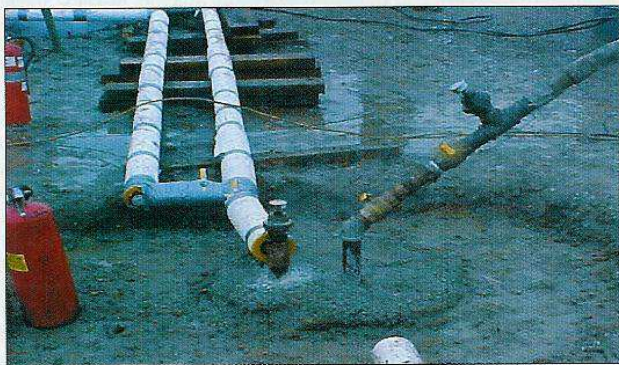
Figure 14 Insulated hot bitumen and cement based grout piping system

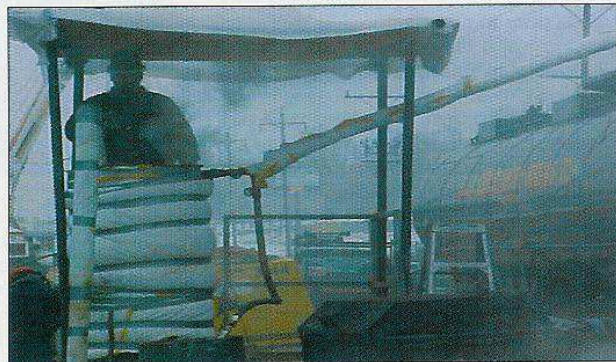
Figure 15 Hot bitumen transfer station
