**Pre-conditioning/Pre-excavation Grouting of the Soils Prior to Tunnelling Below Highways  
& Railways:  
Case Histories from the Past Decade**

**ABSTRACT**

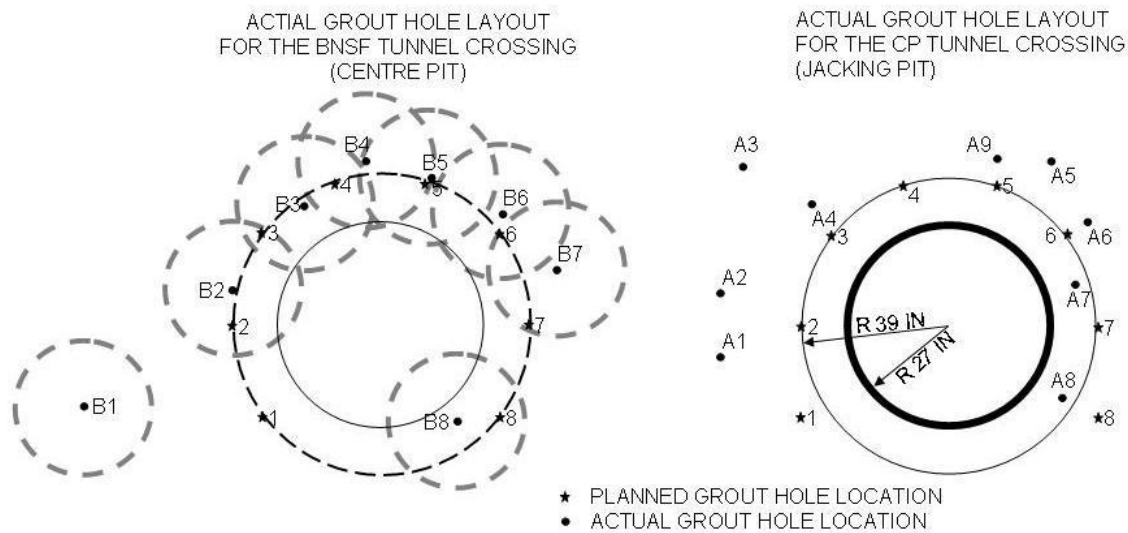
Figure 2: Grout hole layout for the BNSF and CP railway crossing

**The grouting program.** To ensure the integrity of the infrastructure during tunnelling, a grouting program was implemented prior to tunnelling. Due to the restrictions imposed by the railway companies, no sleeve pipes could be installed in the upper 3 feet of overburden below the railway tracks. Eight horizontal sleeve pipes were therefore installed around and outside of

the perimeter of the planned tunnel trajectory to create a grouted soil conglomerate as depicted in Figure 2. Steel sleeve pipes were selected in lieu of plastic pipes in order to create a reinforced grouted soil conglomerate, acting as a forespiling system. Two injection passes of regular cement based suspension grout and two injection passes of sodium silicate based grout was performed in each sleeve pipe in order to allow the least pervious soil layers to be treated following the injection of the most pervious layers in previous passes. To ensure that the grouting pressures would not raise the railway tracks, monitoring points on the tracks were surveyed frequently and the grouting operation was monitored in real-time using the CAGES NS system, which allowed to detect hydrofracturing events. Once the theoretical grout volume was injected in all sleeve pipes and we had a record that the adequate grout spread was achieved, the grouting operation was concluded.

**Effect of treatment.** The grouting program resulted in the construction of overlapping grouted soil cylinders forming a continuous arch above the future tunnel trajectory. Typically, these grouted soil cylinders measured 1 meter (3 feet) in diameter, as observed and measured from within the tunnel during the tunnelling operation. The reinforced grouted soil arch around the tunnel allowed the tunnel to be mined safely without having any impact on the railway tracks and underlying utilities. An identical grouting program was implemented under the same railway tracks and utilities a short distance (3 km) away from this location and the same successful outcome was achieved: no settlement was recorded.

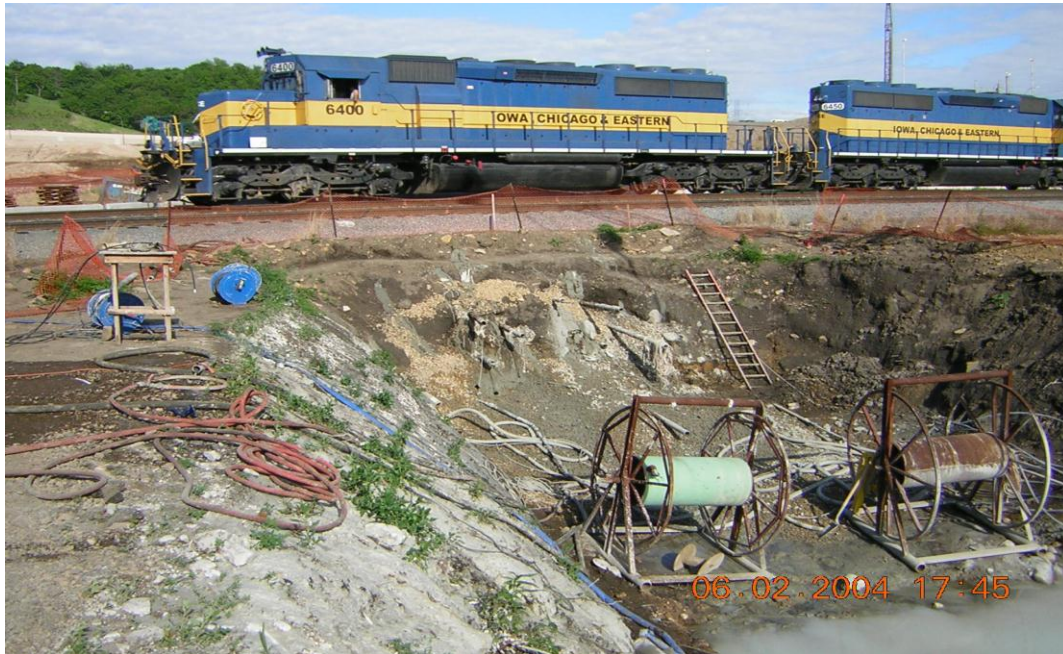
Photograph 1: Sleeve pipes installed through the CP railway embankment around the planned tunnel trajectory

The limited thickness of overburden posed its share of problems during the grouting operation. The lack of confinement caused the grout to easily migrate and break out to surface, which impeded on the grouting progress. Photograph 1 illustrates the sleeve pipes installed in the CP

railway embankment and several grout leaks (breakout to surface) which occurred during grouting due to the lack of overburden confinement.

The grouting operation was executed in nine injection passes. This allowed the grout to cure in the upper soil layers and systematically create confinement for subsequent injection passes. As the grouting operation progressed, fewer grout leaks to surface were observed, and eventually all sleeves were brought to refusal.

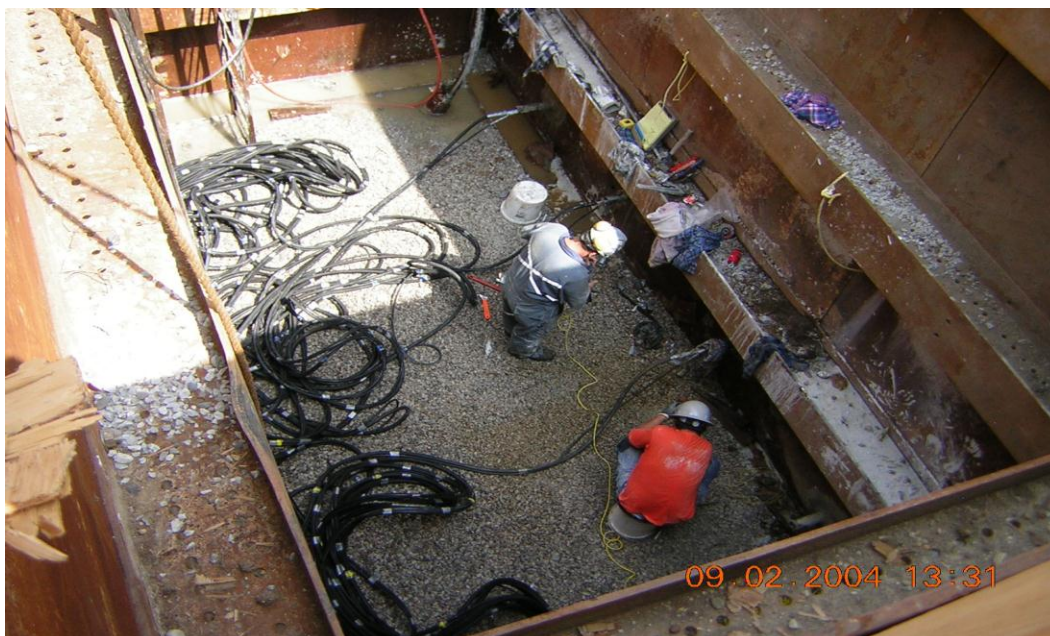
Photograph 2: Grout injection being performed from within the West side access shaft

**The grouting program.** A multiple hole, multiple injection pass grouting program was designed and implemented above the tunnel trajectory. The grouting program consisted of injecting regular cement based suspension grout and sodium silicate based grouts utilizing permeation in conjunction with hydrofracturing grouting techniques through steel sleeve pipes installed above the tunnel trajectory. Two access shafts were constructed on either side of the highway to facilitate the installation of the horizontal sleeve pipes and to perform the grouting. Photograph 2 illustrates the grouting being performed from the West side access shaft. In lieu of grouting a large block of soil, a relatively thin reinforced grouted soil arch was proposed instead, in order to create a continuous, grouted soil arch. Four 4 sleeve pipes were installed approximately 5 feet above the tunnel trajectory (equally spaced 5 feet apart) to perform the pre-excavation grouting. An additional 2 sleeve pipes (installed approximately 2 meters (7 feet) above the first row of sleeve pipe) were installed as depicted in Figure 3. The second row of holes was installed as a precautionary measure in the event that compensation grouting would be required. The compensation grouting program would have involved injecting a cement based suspension grout above the tunnel trajectory during tunnelling operations. Any soils loosened by the tunnelling activities would have been replaced with cement based suspension grout, therefore reversing any soil disturbance. A total of 3 injection passes were performed through each of the four each sleeve pipes. The first pass consisted of injecting a regular cement based suspension grout, while subsequent passes were performed with a sodium silicate based grout. The CAGES NS grouting system was utilized to monitor, assess and evaluate the grouting operation in real time, which made it possible to inject on all 4 grout holes simultaneously.

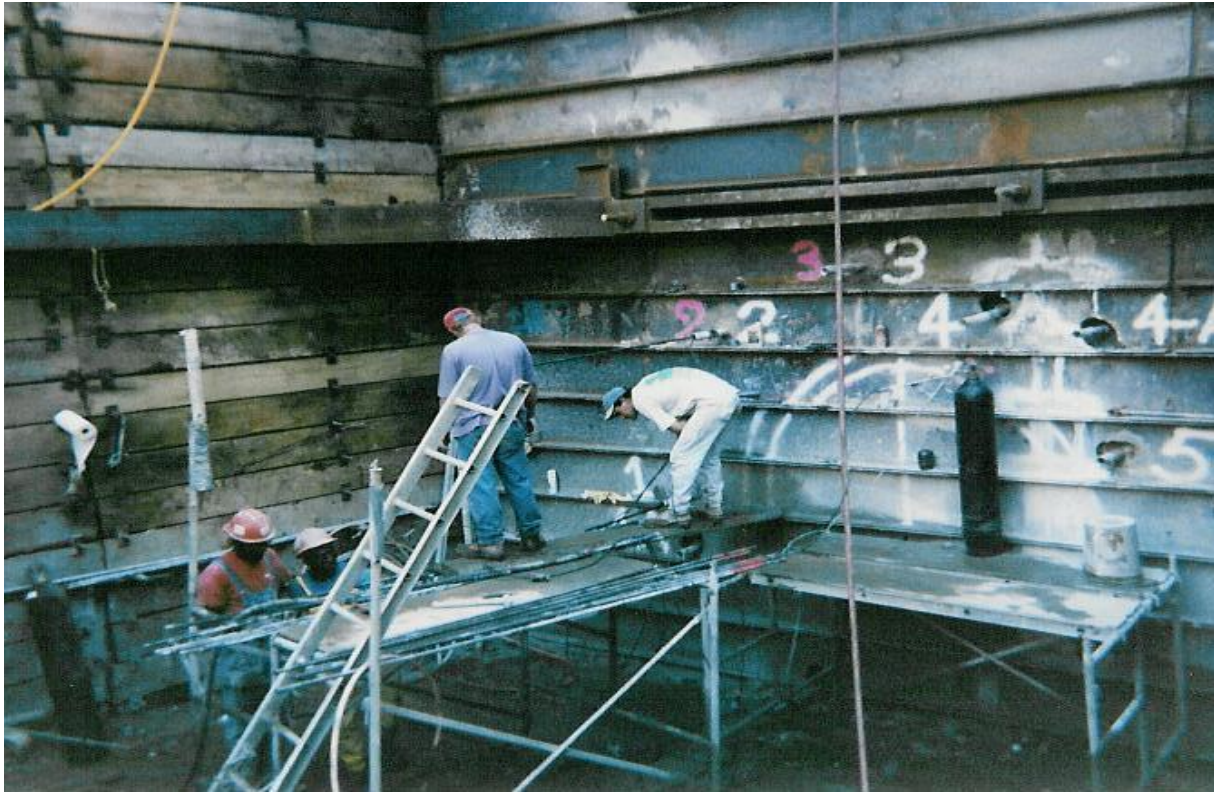
Photograph 4: Grouting crew performing injection of sodium silicate based grout via the sleeve pipes

**The grouting program.** An extensive grouted soil-conglomerate arch was created above the tunnel trajectory to prevent settlement of the CP Rail tracks during the excavation of the sewer tunnel through the underlying embankment. Photograph 4 depicts the grouting crew during the injection of sodium silicate grout via one of the sleeve pipes. The grouting program included the following:

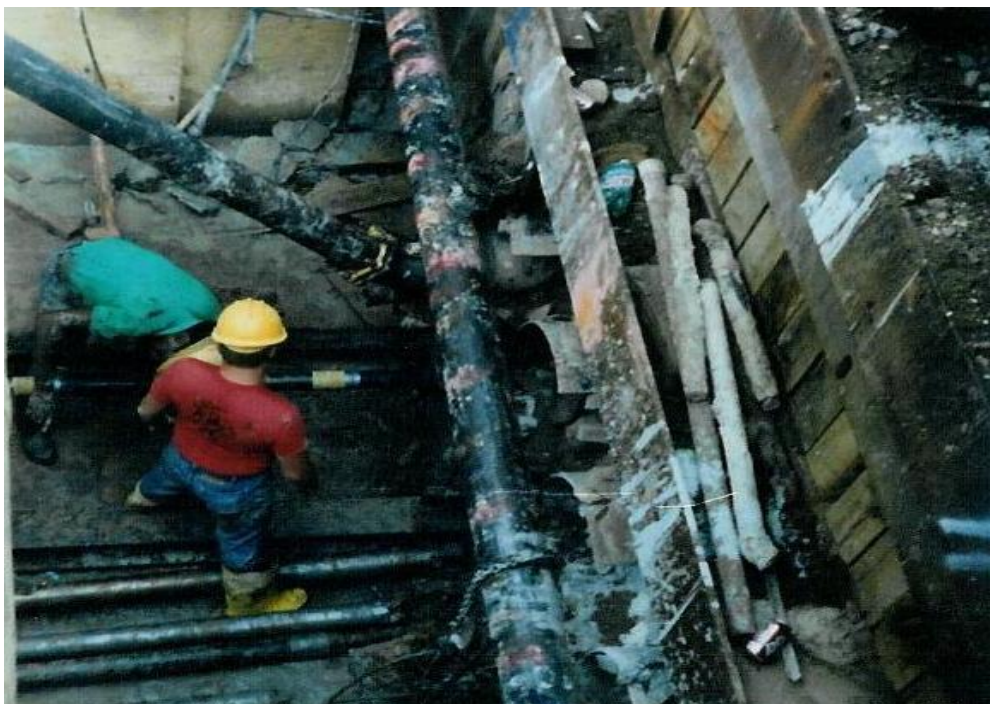
Photograph 5: Grouting crew during the installation of one of the steel sleeve pipes

All sleeve pipes and several mechanical packers were built on site. A total of 25,890 gallons of regular and microfine cement based suspension grouts were injected. When the tunnelling operation resumed, no further settlement was recorded. The grout injected in the formation in conjunction with the forespiling system allowed for the safe construction of the tunnel below the railway tracks.
