Grouting technology improves structure

Restoration of Rideau Canal Historical Locks

by Luigi Narduzzo and Alex Naudts

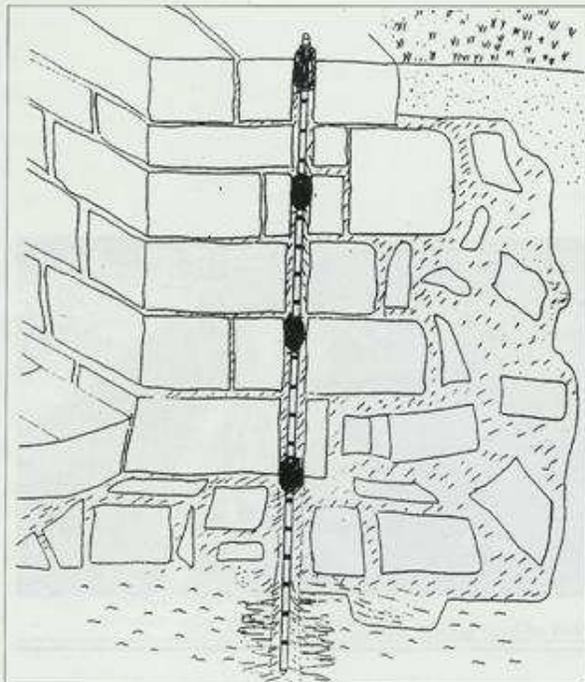
Fig. 1 — MPSP system.

In order to separate the drilling from the grouting operation, Multiple Packer Sleeve Pipes (MPSP) were developed. The system was developed for drilling and grouting in caving (unstable) rock formations. Fig. 1 is a pictorial representation of an MPSP system as it has been installed in the lock chamber walls on the various projects. An MPSP pipe is a modified sleeve pipe consisting of a plastic pipe with perforations every 0.33 or 0.50 m along the pipe. The perforations are protected by rubber sleeves acting as one-way valves during grouting. In order to isolate the grout hole into separate zones, concentric geotextile barrier bags are strapped over a number of the rubber sleeves in the sleeve pipe. The barrier bags are firmly attached, uninflated, to the sleeve pipe with clips above and below the rubber sleeve selected as the barrier. They typically are 0.40 to 0.60 m long. After the hole is drilled, the MPSP is installed in the cased hole. This operation allows the separation of the drilling operation from the grouting.

Barrier bag grouting

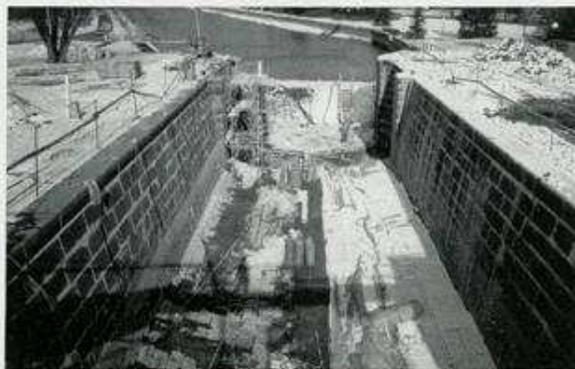
View of lock under repair.

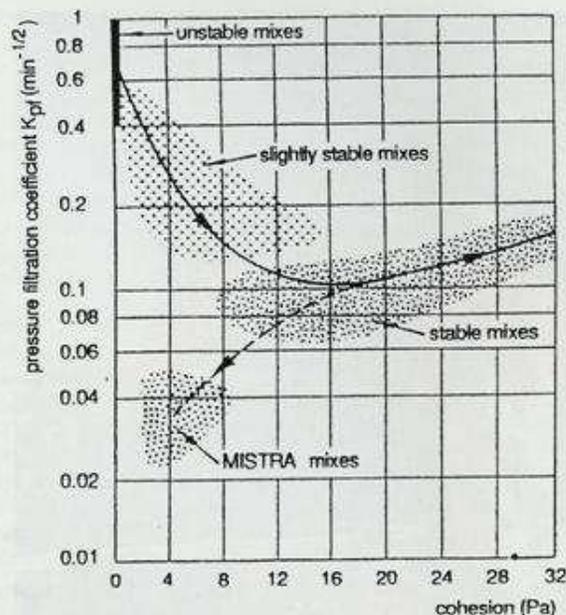
Fig. 2 — Pressure filtration coefficient vs. cohesion.²

A suspension grout should be characterized by its pressure filtration resistance coefficient, K_{pf} , its solid con-
